# GEOTECHNICAL STUDIES OF THE VISWEMA SLIDE, KOHIMA, NAGALAND

Meniele Khalo<sup>1</sup>, Soibam Ibotombi<sup>2</sup>, Supongtemjen<sup>3</sup>, Glenn T. Thong<sup>4\*</sup>

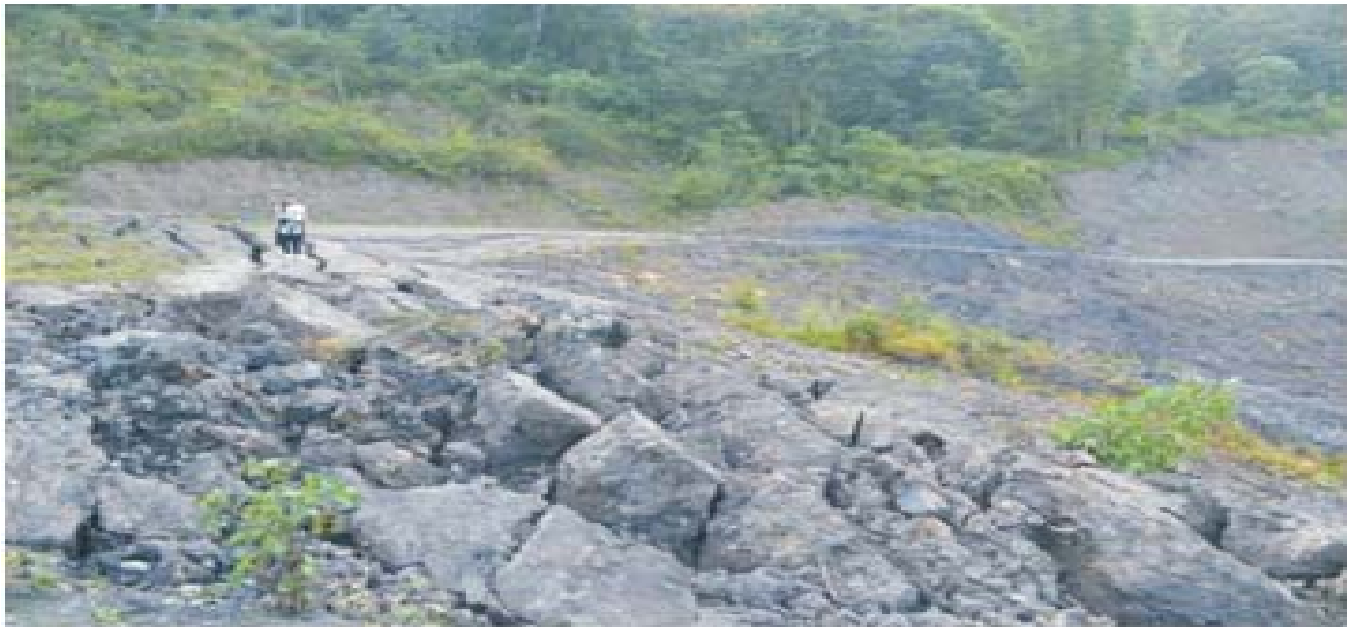
Studies were carried out to ascertain the factors responsible for instability. This is a very unstable area that was affected from the early 1960's and has continued to pose problems till today (Figure 2). Highway blockage in the past often disrupted communication between Kohima and Imphal. The length of the active slide zone is about 1200 m while the breadth is about 440 m, covering an area of 408139.48 sq m. Maximum damage to the highway included a length of 120 m, which kept the Border Roads Organisation constantly busy to keep it functional. Retaining walls are continuously constructed but they did not last long as their

foundations are constructed on slide debris. Moreover, the heavy foundations exert additional burden on the soil mass. The drains constructed were shallow and ill maintained. Hence, abundant water was allowed to percolate into the subsurface. Change in water content can affect the stability of slope material and have been responsible for triggering, reinitiating, and accelerating more landslides than any other factor [4]. Meusburger and Alewell [5] claim that enhanced anthropogenic activity and adverse environmental factors lead to increase in landslide activity.

*Figure 2. Damaged highway*

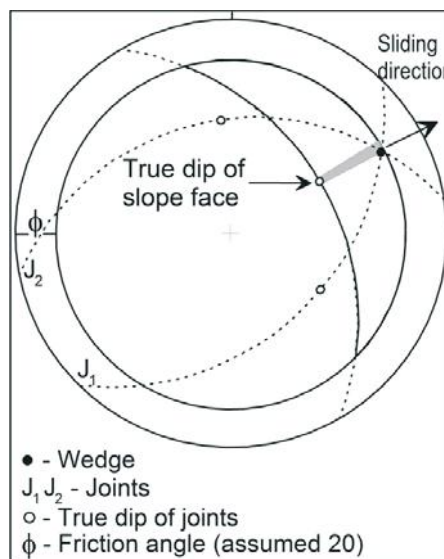
**Figure 3c. Stereogram**

The diagram shows a distinct wedge due to the intersection of joints  $J_1$  and  $J_2$ . Cruden [12] suggests double-plane wedge failure in such cases as the true dips of both joints lie outside the shaded area. A rose diagram of this area (Figure 3d) shows that the

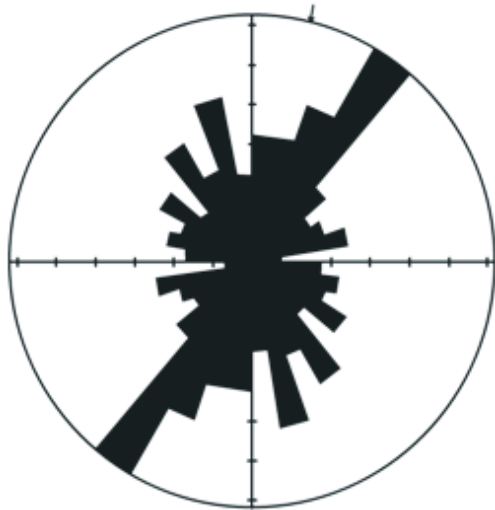
Figure 3d. Rosette

lineaments are in conformity with that of the general trend of the region that is affected by  $F_1$  folds. The rocks are thrust along this plane. Antithetic and synthetic shearing stresses have also played a role in rock deformation.

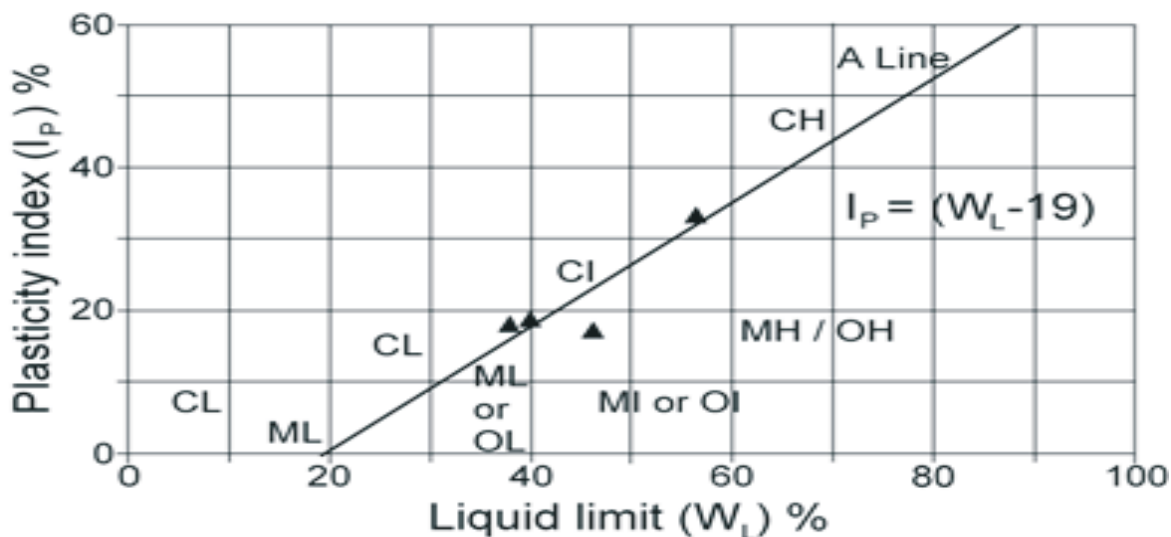
Figure 4. Plasticity chart (IS: 1498-1970)

Consistency limits of the slope material were determined to understand the firmness of the soils. A plasticity chart (Figure 4) prepared for the soils indicate that soil samples falls under OI group,

which is indicative of organic silts of medium plasticity and between CI and MI group, depicting that the soils are inorganic clays of moderate plasticity and inorganic silts of moderate plasticity.

Consistency index values computed from the maximum water content show values less than 0 (negative) indicating that failure took place during the liquid stage. The moisture content of the soils is greater than the liquid limit, which suggests that the soils were already in a liquid state at failure. Since data was collected after the rainy season, values of the maximum moisture content have been considered. Therefore, with or without additional water in the area the zone is bound to give way.

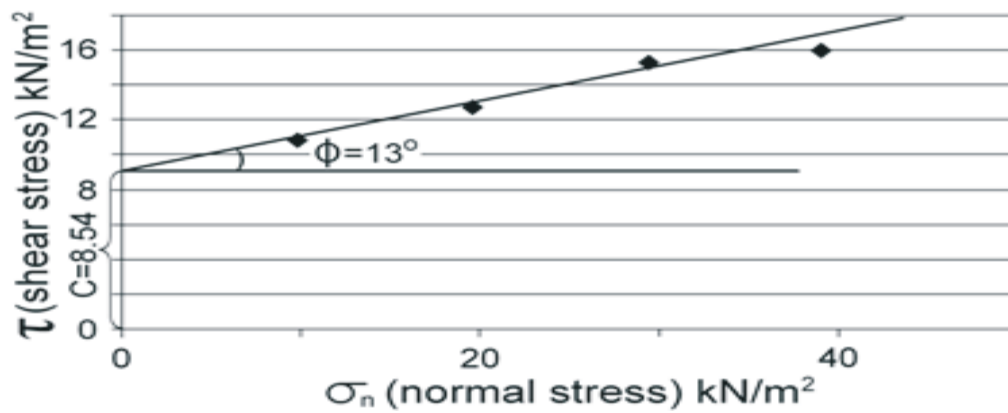
Figure 5. Plots of normal and shear stresses

Normal ( $\sigma_n$ ) and shear stresses ( $\tau$ ) are plotted against each other (Figure 5). A best fit line gives the Coulomb failure equation,  $\tau = c + \sigma_n \tan \phi$ . The cohesion

and internal friction angle of the soil determined are 8.54 kN/m<sup>2</sup> and 13 respectively.

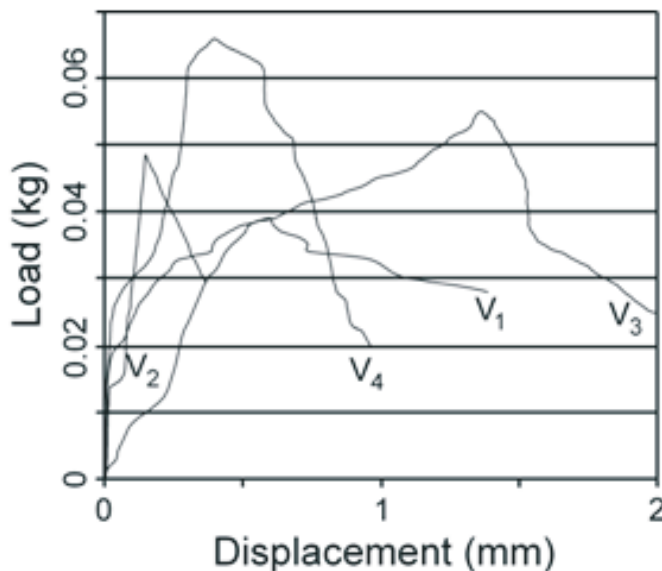
Figure 6. Stress / strain curves of the samples

The stress and strain, i.e., load and displacement curves of the four samples were plotted to determine the geotechnical nature and behavior of these soils (Figure 6). From the graphs it appears that these soils are mainly clay with some amount of silt and sand; all the samples have good amount of clay except  $V_1$  which has some amount of silt and

could be applied in phases until the desired reduction in movement is accomplished. sand. As the cohesive strengths as well as internal friction angles are low, these could be mostly clay with a little silt and fine sand. The value of cohesion ( $c$ ) is  $8.54 \text{ kN/m}^2$  while the internal friction angle is  $13^\circ$ . Such slopes cut more than the internal friction angle are virtually unstable.
