# RISK ANALYSES ALONG PART OF NH 2, NORTH OF KOHIMA TOWN, NAGALAND

**Supongtemjen and Glenn T. Thong\***

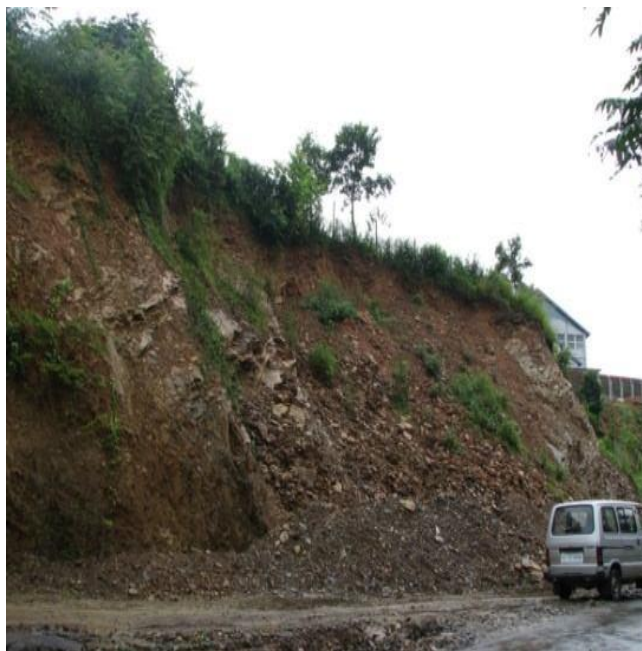
This small slide, lying at  $25^{\circ}42'39''$  N latitudes and  $94^{\circ}04'22.41''$  E longitudes, to the west of the Indoor Stadium, covers about 230 sq m. It has affected a 40 m stretch of the highway (Fig. 2). The slope is made up of sheared, jointed, and partially weathered shale. This is overlain by debris and young soils. The general trend of the slope ranges from  $25^{\circ}$  to  $32^{\circ}$  in a WSW direction. The rocks exhibit three prominent sets of joints. Widening of the road has left the weak slope, which is prone to continuous sliding, as high as 12 m with an average angle of  $55^{\circ}$ .

**Figure 2.** Debris slide in sheared rocks

Location 1: Surface runoff along the slide zones should be channelized effectively by a good roadside drain. An appropriately designed retaining wall along the road is necessary to arrest the slope mass.

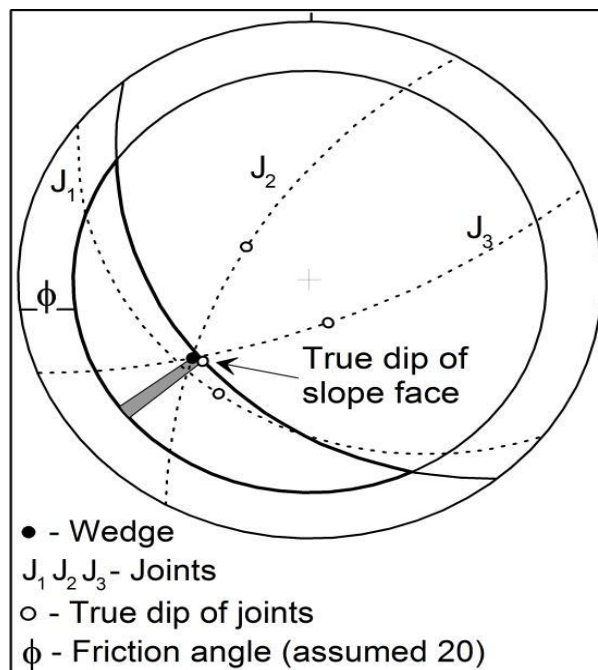
**Figure 3.** Stereographic projection (Location 1)

SMR values fall in Class IV, indicating unstable slope conditions (Table 1). From the contour diagrams of joint attitudes, three dominant joint sets are identified, which are plotted against slope in a stereographic projection (Figure 3).

Slope :  $50^{\circ}230^{\circ}$   
 $J_1$  :  $45^{\circ}217^{\circ}$   
 $J_2$  :  $69^{\circ}300^{\circ}$   
 $J_3$  :  $76^{\circ}159^{\circ}$

The true dips of the joint planes  $J_2$  and  $J_3$  lie outside the shaded region. The intersections of these joints indicate that the rocks may fail as small wedges.  $J_1$  plotted against slope shows planar mode of failure. A hybrid fracture is responsible for shearing the rocks, thereby rendering the slope prone to sliding.

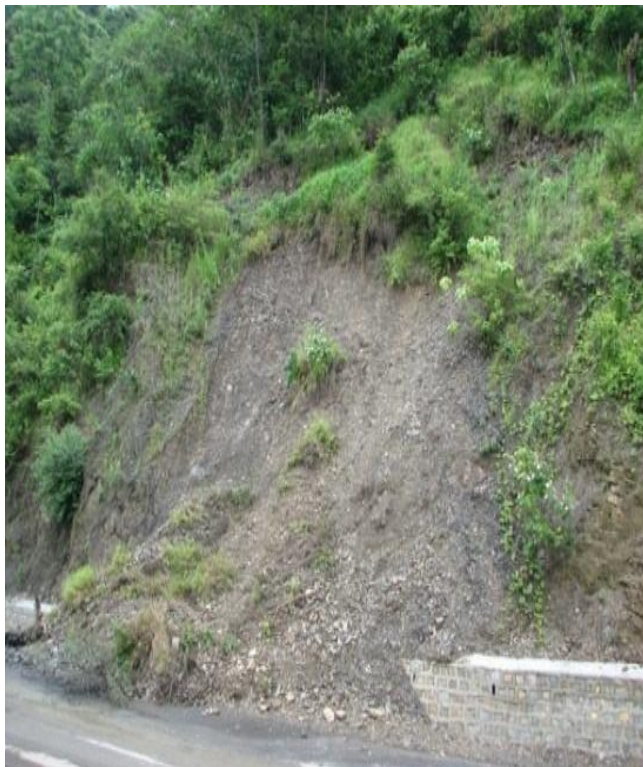
This debris slide lies at  $25^{\circ}42'50.30''$  N latitudes and  $94^{\circ}05'16.94''$  E longitudes. The rocks are jointed and fractured. They comprise shale and minor siltstone with black and brown clay. The wide gaps in the fractures and joints are filled with clay. Rock dips are variable due to local structural disturbances. Three prominent sets of joints are noted. The upper slopes are covered by vegetation (Figure 4). The slope, varying in height from 6 to 15 m, has been left at an angle of about  $80^{\circ}$ .

Figure 4. Debris slide in crushed zone

Location 2: The present retaining should be built higher and requires to be extended through the entire length of the affected area.

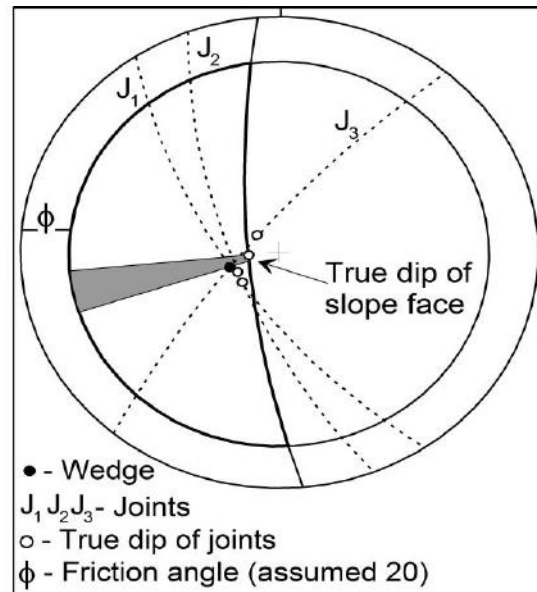
Figure 5. Stereographic projection (Location 2)

RMR values indicate weak rocks and SMR values indicate unstable slope conditions (Table 2). From joint analyses three dominant joint sets are identified, which are plotted against slope attitude in a stereographic projection (Figure 5).

Slope :  $80^{\circ} 265^{\circ}$   
 $J_1$  :  $74^{\circ}236^{\circ}$   
 $J_2$  :  $75^{\circ}249^{\circ}$   
 $J_3$  :  $81^{\circ}310^{\circ}$

The true dips of the joint planes  $J_1$  and  $J_3$  lies outside the shaded region between the true dip of the slope and the line of intersection of the two joint planes ( $J_2$  and  $J_3$ ).  $J_2$  plotted against slope indicates probable planar failure. Joint intersections ( $J_2$  and  $J_3$ ) suggest that the rocks may further break into small blocks.

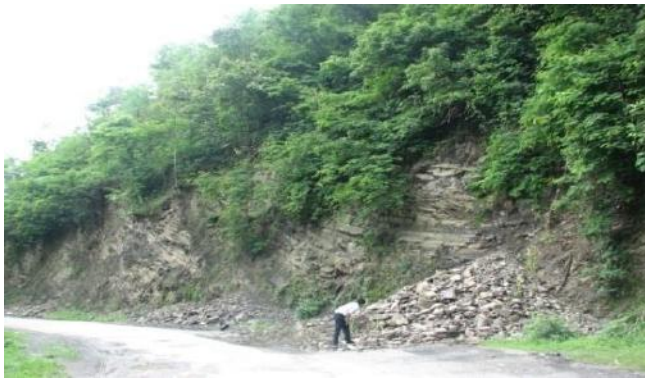
about  $75^\circ$ . Debris slides have affected about 120 m of the road (Figure 6). The folded shale intercalated with minor siltstones are jointed and fractured. The bedrocks dip  $70^\circ$  towards  $55^\circ$ NE. The rocks exhibit three prominent sets of joints. The first set of joints trends WNW-ESE with moderate dips towards SSW. The second set trends NW-SE with almost vertical dips towards SW. The third set trends NNE-SSW with near vertical dips towards the SE.

**Figure 6.** Debris slide in fractured rocks

Location 3: The vertical exposed rock surface should be bound with GI wire to prevent debris falls. Regular maintenance is necessary.

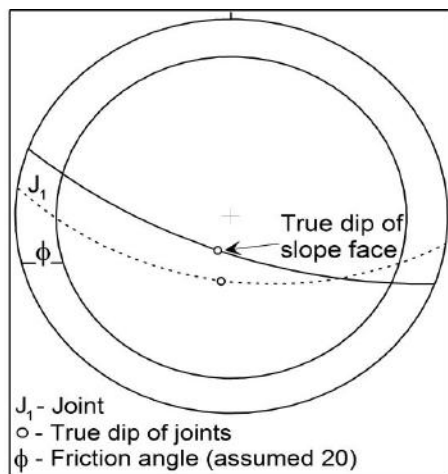
**Figure 7.** Stereographic projection (Location 3)

RMR values indicate weak rocks and SMR values of Class V indicate very unstable slope conditions (Table 3).  $J_1$  ( $63^\circ/188^\circ$ ) is identified as the dominant joint which is plotted against slope attitude ( $75^\circ/200^\circ$ ) in a stereographic projection (Fig. 7). The true dip of the joint plane  $J_1$  lies at an angle of  $\pm 12^\circ$  with respect to the true dip of the slope face. Such a relationship may cause planar failure.

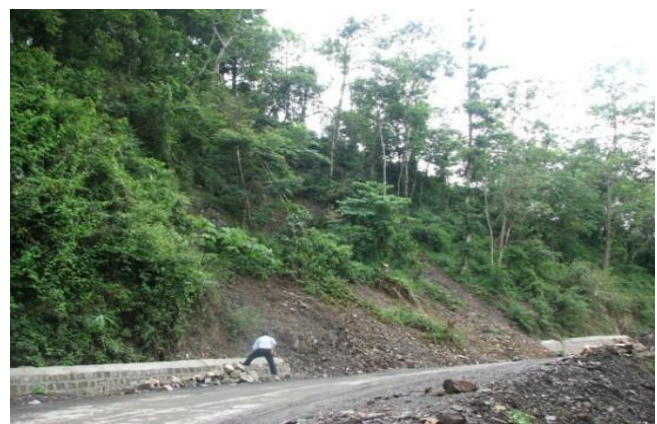
This section is located at  $25^\circ 42' 59.15''$  N latitudes and  $94^\circ 05' 5.50''$  E longitudes. A debris slide damaged a 50 m stretch of the highway (Figure 8). The rocks are highly crushed and weathered. Three prominent sets of joints are noted. The crumbled and weathered shale are capped by loose debris on a  $75^\circ$  slope at this location. The height of the slope is approximately 10 m. Water enters the joints and loose debris to saturate the slope material. The upper portion of the area is clad with trees planted a couple of years back, which add to the load on the weak slope.

**Figure 8.** Debris slide in crushed zone

Location 4: Appropriately designed, higher retaining walls are necessary. Trees from the upper slope should be removed.

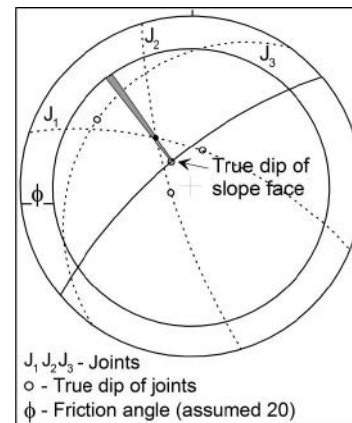
**Figure 9.** Stereographic projection (Location 4)

RMR values indicate the presence of weak rocks while SMR values indicate unstable slope conditions (Table 4). Joint data are plotted against slope attitude in a stereographic projection (Figure 9).

Slope : 75° 320°  
 J<sub>1</sub> : 70°20°  
 J<sub>2</sub> : 80°253°  
 J<sub>3</sub> : 33°305°

The true dips of the joint planes J<sub>1</sub> and J<sub>2</sub> lie outside the shaded region. The area is prone to double plane wedge and planar failure. Shearing effects of the lineament has helped crush the rocks.

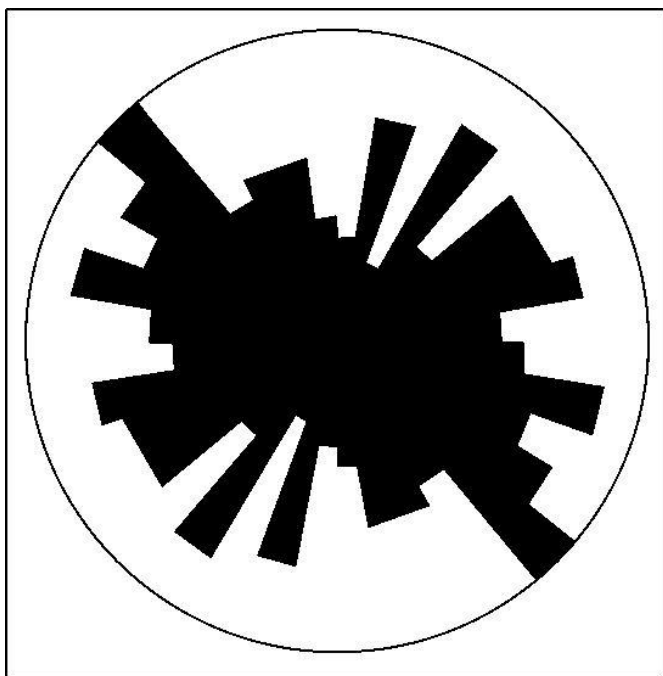
**Figure 10.** Rose diagram of joints

A rose diagram of joints of the region (Figure 10) shows concentration along NW-SE. These joints are due to tensile stresses that are concentrated around the regional NW-SE compression. Another set of joints trend NW-SE which is parallel to the regional trend. As a consequence hybrid fractures have developed in the terrain due to the interplay of these stresses causing extensive deformation of the rocks. Jointing and fracturing have considerably weakened the rock masses thereby initiating extensive weathering to produce thick mantles of waste, making the area susceptible to sliding, particularly during the monsoon.
