STABILITY ANALYSES OF TWO FRESH CUT SLOPES ALONG NH 2, MERIEMA, NAGALAND

Supongtemjen¹, Temsulemba Walling², Sohi Tep², and Glenn T. Thong^{2*}

²Department of Geology, Nagaland University, Kohima Campus, Meriema

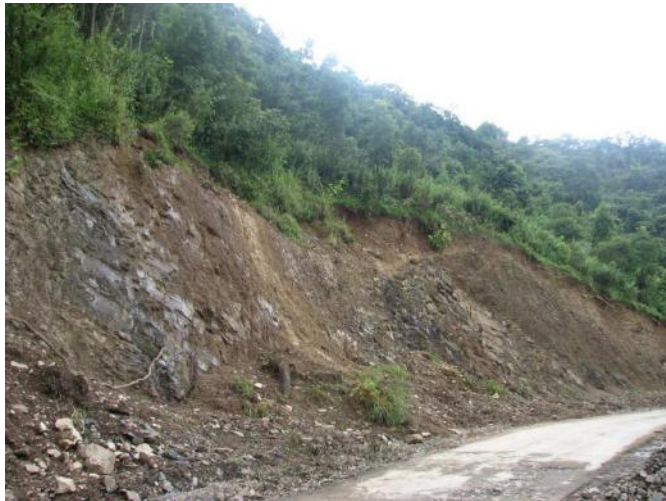
This area is located at 25°44'12.41" N latitude and 94°04'59.52" E longitude (Fig. 1 - 1). Debris falls and slides are fairly common with about 110 m of the road being affected in 2007 (Fig. 2). The area is made up of partially weathered shale capped by weak soil, the thickness of which ranges from 2 to 3 m. The rocks are jointed, fragmented, and weathered due to which debris continuously slides downhill to block the roadside drain and part of the highway. The bedrocks dip about 30° towards 135° SE. Three prominent sets of joints are noted. The first set of joints trends NW-SE dipping at angles of 45° towards SW. The second set trends N-S, dipping towards 270° W and the third set trends NNE-SSW, dipping 72° NNW. The triggering factor for instability in this section of the highway is a combination of steep slope, adverse lithology, and structure. The height of the unstable slope here is about 10 m with an inclination of 75°. Such slopes made up of partially weathered shale overlain by loose debris and soil are highly prone to slope failure.

Fig. 2. Weak slope material

- a. Reduction of slope angle in the upper soil horizon and removal of 3 m of the top soil is recommended (Fig. 4).
- b. A geotextile cover and grass plantation on the excavated soil will greatly help.
- c. About 100 m length of the rock section treated with GI wire netting will provide stability to the slope.
- d. Proper roadside drainage is necessary.

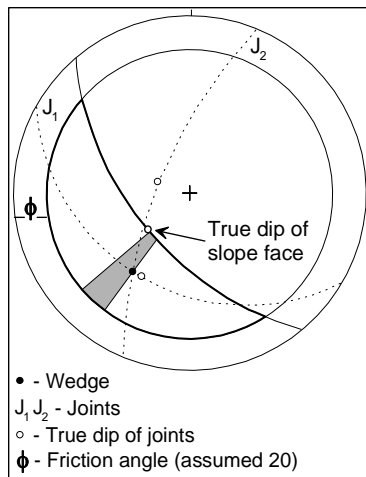
Fig. 3c. Stereogram

Forty five rock samples were collected from the site for determination of their strengths. The RMR value of 39 (Table 2) obtained indicates weak rock. SMR values fall in Class IV indicating unstable slope conditions. This also indicates potential planar or wedge failure.

The figure shows the development of a distinct wedge due to the intersection of these two joint sets. Both the true dips of these joints lie outside the shaded area. The intersection of J_1 and J_2 forms a double plane wedge. A rose diagram (Fig. 3d) indicates thrusts (NE-SW) and possible tensile fractures (NW-SE) affecting the rocks.

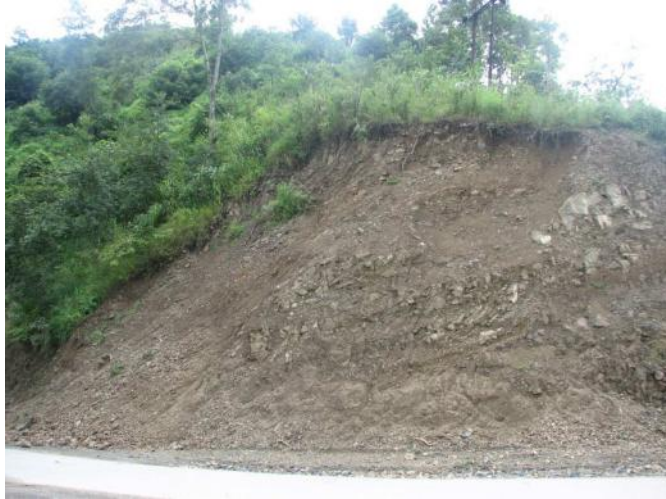
This area located at $25^{\circ}44'18.08''$ N latitudes and $94^{\circ}05'1.05''$ E longitudes (Fig. 1 - 2) was affected by minor but continuous debris slides (Fig. 5). The slope materials making up the area are crumpled Disang shale. The upper horizons comprise debris and loose soil. Bedrocks are not exposed along the section but outcrops in the vicinity show a number of joints. Two prominent sets of joints control rock behavior. The first set of joints trends ENE-WSW, dipping at an angle of 54° towards NNW. The second set trends N-S and dips 53° towards the west. The cause of this instability is due to weak lithology on a high (10 m) and steep slope with a gradient of 70° .

Fig. 5. Weak hill slope

- a. The free face of the slope is steeply inclined hence, benching along a length of about 80 m is recommended to increase stability (Fig. 7).
- b. A carpet of grass planted on the exposed surface will help hold the soil and prevent excess seepage of water into the soil.

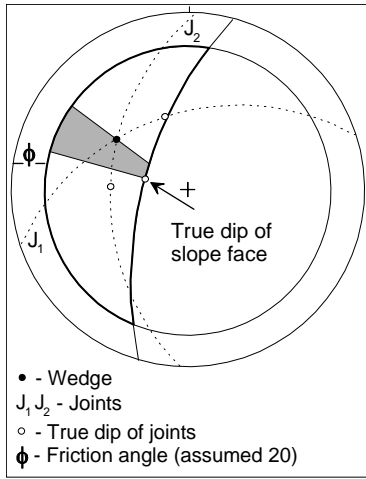
Fig. 6c. Stereogram

Forty rock samples were collected from the site for strength determination. The RMR value of 46 indicates fair weak rock. SMR values fall in Class III, which indicates partially stable conditions (Table 4).

The stereographic projection shows the development of a distinct wedge due to the intersection of these two joint sets. The true dips of both J_1 and J_2 lie outside the slide envelope (Fig. 6c). Cruden (1978) suggests double plane wedge failure in such cases. The rose diagram (Fig. 6d) suggests complex deformation, including shearing of the rocks.
