STABILITY ANALYSES OF TWO FRESH CUT SLOPES ALONG NH 2, MERIEMA, NAGALAND

Supongtemjen¹, Temsulemba Walling², Sohi Tep², and Glenn T. Thong^{2*}

²Department of Geology, Nagaland University, Kohima Campus, Meriema

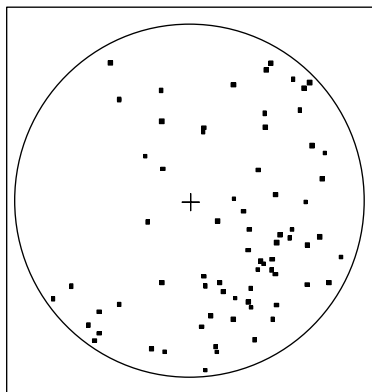
Fig. 3a. Pole diagram

200 joint attitudes taken in the field were used to construct pole density (Fig. 3a) and contour diagrams (Fig. 3b) and from which two dominant joint sets that lend instability to the slope were identified. These were plotted in a stereographic projection against slope (Fig. 3c).

1. Slope : 65° → 230°
2. J₁ : 45° → 210°
3. J₂ : 75° → 292°

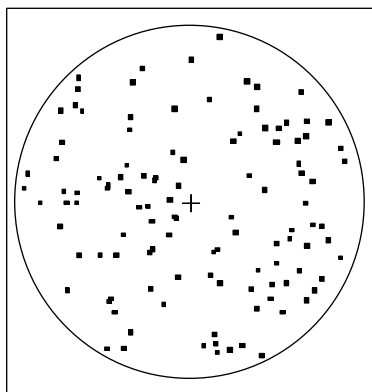
Fig. 6a. Pole diagram

200 joint attitudes were analyzed and two sets of joints deciphered from the pole (Fig. 6a) and contour diagrams (Fig. 6b) to cause instability to the slope, due to interference.

1. Slope : $70^\circ \rightarrow 284^\circ$
2. J_1 : $54^\circ \rightarrow 272^\circ$
3. J_2 : $53^\circ \rightarrow 320^\circ$
